Bridge Assessment

West Springfield Solar EIA Report

TRIO West Springfield Solar LLP

29 April 2025

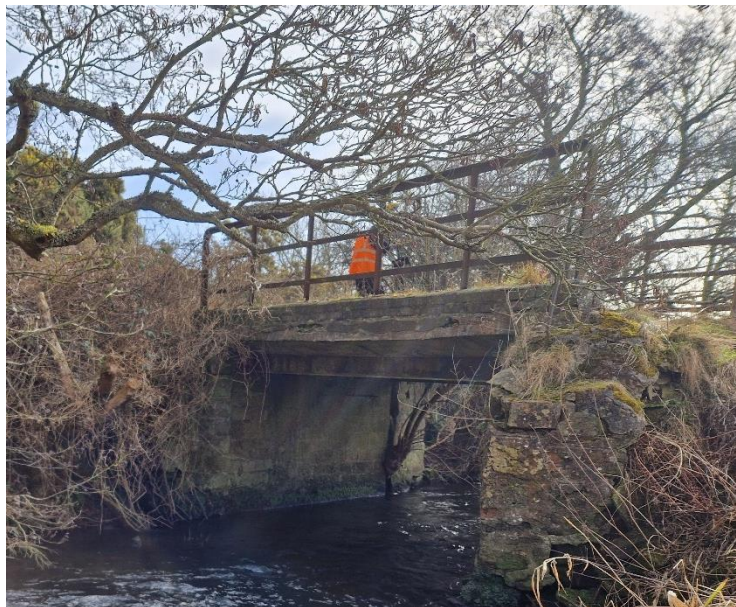
Photo 1 - Existing Bridge Structure

- 3.1.1 SLR attended site on Monday 3rd March 2025. The site inspection was undertaken by Ross Manson (Associate Civil Engineer) and Angus Dickson (Project Civil Engineer) from SLR. The inspection conditions were good, and the river water level was low enough that a detailed inspection of the existing structure was possible.
- 3.1.2 SLR reviewed the existing bridge structure, shown below in Photo 1 located at National Grid Reference: NO 33020 11253 (What Three Words: faster.salary.guitar). No historical records were available regarding the structure's construction date or original purpose. However, based on its location, design and materials, it is presumed to have been constructed for farm traffic. This structure was selected for review as it appears to be best located to handle the proposed construction traffic.

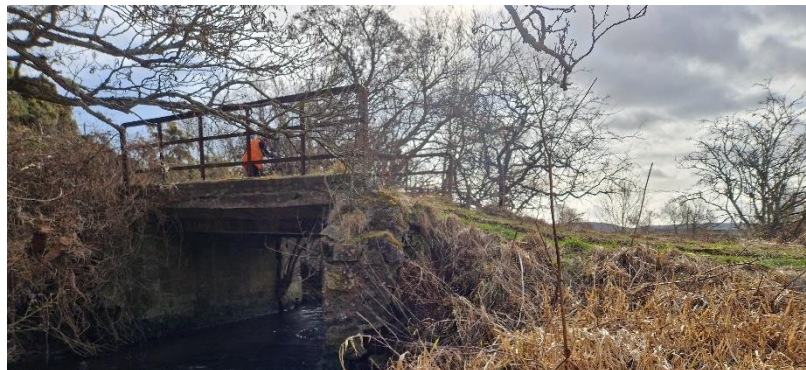
Photo 2 - Drop on Eastern End

- 3.2.3 The road is 4.3m wide between the bridge parapets, which are composed of metal railings embedded in a raised brick masonry edge. The road has a cobbled stone finish above a concrete deck, which is only visible below. The road surface is overgrown across the bridge, other than defined tyre tracks. On the west side of the bridge at the end of the span the road surface abruptly falls away onto a steep dirt track as seen in Photo 2, which would require regrading to be suitable for construction traffic. The east side track rises away from the bridge.

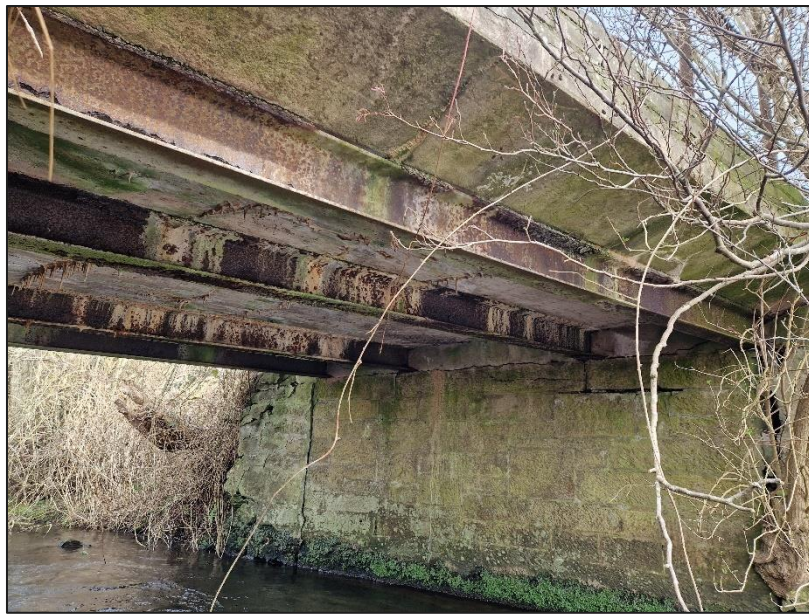
Photo 3 - Bridge Structural Arrangement

- 3.2.4 The main bridge support is provided by the four steel I-beams, these are not distributed equally and appear to perhaps have been positioned to better manage wheel loadings. The I-beams were measured at 203mm in height and 130mm in width with a 10mm steel thickness on the flange, this would be consistent with a standard beam 203x133x30UB. The beams are projected into the masonry

- abutments with a concrete surround and while not visible it is assumed that they have a simple fixed end bearing connection.
- 3.2.5 The concrete deck is visible on the underside of the bridge and spans across the four steel beams. The deck thickness varies, with a noticeable reduction in depth beyond the outermost steel beam towards the bridge edge.
- 3.2.6 Photo 3 shows the general arrangement of the underside of the bridge, with the four steel beams projecting into the masonry abutments and the concrete deck.

- 3.3.7 Significant calcium carbonate deposits were observed, forming stalactite-like formations. These deposits likely result from efflorescence or leaching, indicating moisture penetration into the concrete, either through the road surface or from the river below. These formations appear to be a significant cause of moisture and corrosion around the steel beams. The presence of these deposits suggest that moisture is penetrating the concrete which could indicate cracking and loss of cement binder, this could lead to an accelerating corrosion and loss of strength of the concrete deck. These can be seen as the white discolouration in Photo 3.

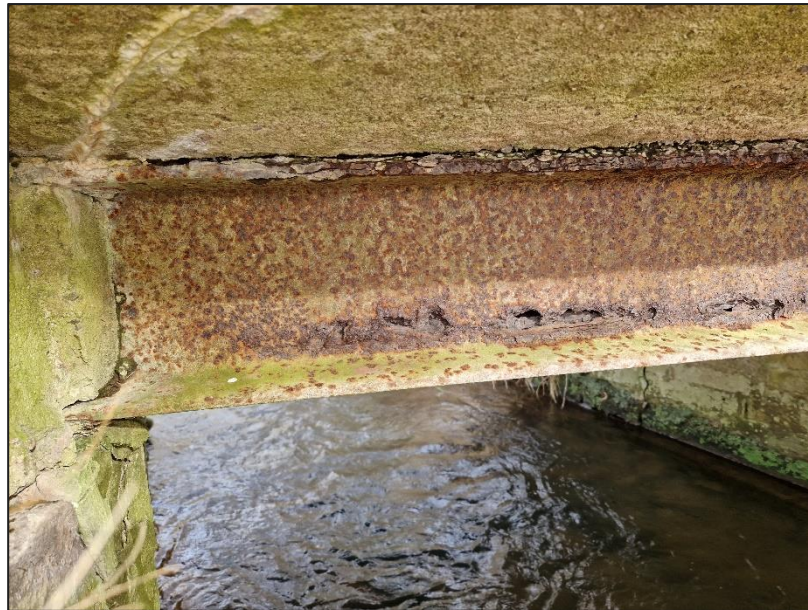
Photo 4 - Steel Beam Corrosion

- 3.3.2 The Steel I-Beams were in poor condition. Severe corrosion was observed on all steel beams, with notable section loss, particularly in the web and top flange, where perforations were present. The pitting suggests deep material loss beyond surface oxidation only, which will have resulted in loss of section.
- 3.3.3 This corrosion will have severely reduced the structural capacity of the beams. Photo 4 below evidences the corrosion evident. The corrosion was not consistent across all four beams, the downstream beam appeared to be in worse condition than the others, though there is no apparent reason why this should be the case.
- 3.3.4 Despite the section loss, no visible deflection or bending of the steel beams was observed. This suggests that, under current loading conditions, the remaining

section retains sufficient capacity to prevent yielding. However, the compromised structural integrity significantly reduces its safe load-carrying capacity.

- 3.4.2 The steel I-beams exhibit extensive corrosion, with perforations and section loss, particularly in the web of some members. This has likely resulted in a substantial reduction in their load-bearing capacity, even though no visible deflection or bending was observed under current loading conditions. Given the pitted nature of the corrosion, it is highly probable that the structural integrity of the beams has been compromised beyond surface-level degradation.

4.3.2 Remediating the bridge would require extensive work, including replacing or strengthening the corroded steel beams, waterproofing and resurfacing the concrete deck to prevent further moisture damage, and stabilizing the abutments

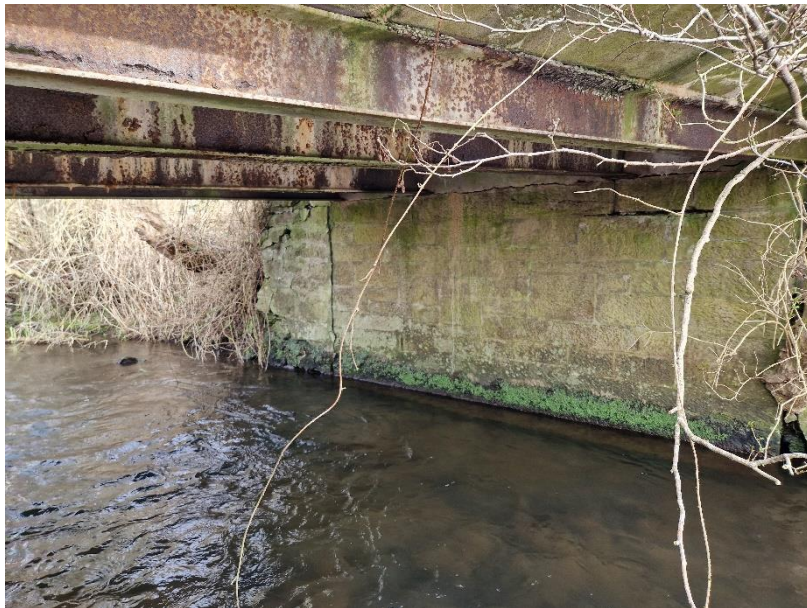
Photo 5 - Abutment Damage

- 3.3.8 The masonry abutments show evidence of damage from the river.
- 3.3.9 On the upstream western corner, river-induced scour has led to backfill washout behind the masonry, resulting in separation between the abutment and retained soil. Although the abutments remain aligned, the loss of backfill compromises their stability. This is likewise seen on the eastern downstream edge of the abutments

- where large vegetation has grown through the masonry and allowed scour and erosion to remove large sections.
- 3.3.10 Prominent vertical and horizontal cracks were observed in the masonry walls. These cracks may indicate differential settlement, loss of mortar integrity, or structural distress due to water infiltration. Crack widths were variable and up to 50mm in places, with larger gaps where stones have been lost.
- 3.3.11 Large, visible cracks in the masonry abutment indicate structural movement as seen in Photo 5 & Photo 6. The crack at the bearing area suggests differential settlement, lateral movement, or washout of backfill material. This might result in the abutment not fully supporting the beam as intended, as the gap appears to be between the underlying masonry and the concrete surround.

- 3.4.4 The bridge abutments have experienced significant erosion and material loss, particularly at the upstream western and downstream eastern corners. This is likely due to a combination of hydraulic scour, washout of backfill, and vegetation growth, which will have compromised structural integrity. The visible vertical cracks within the masonry indicate potential differential settlement or mortar failure, which could lead to progressive instability of the abutments over time. If

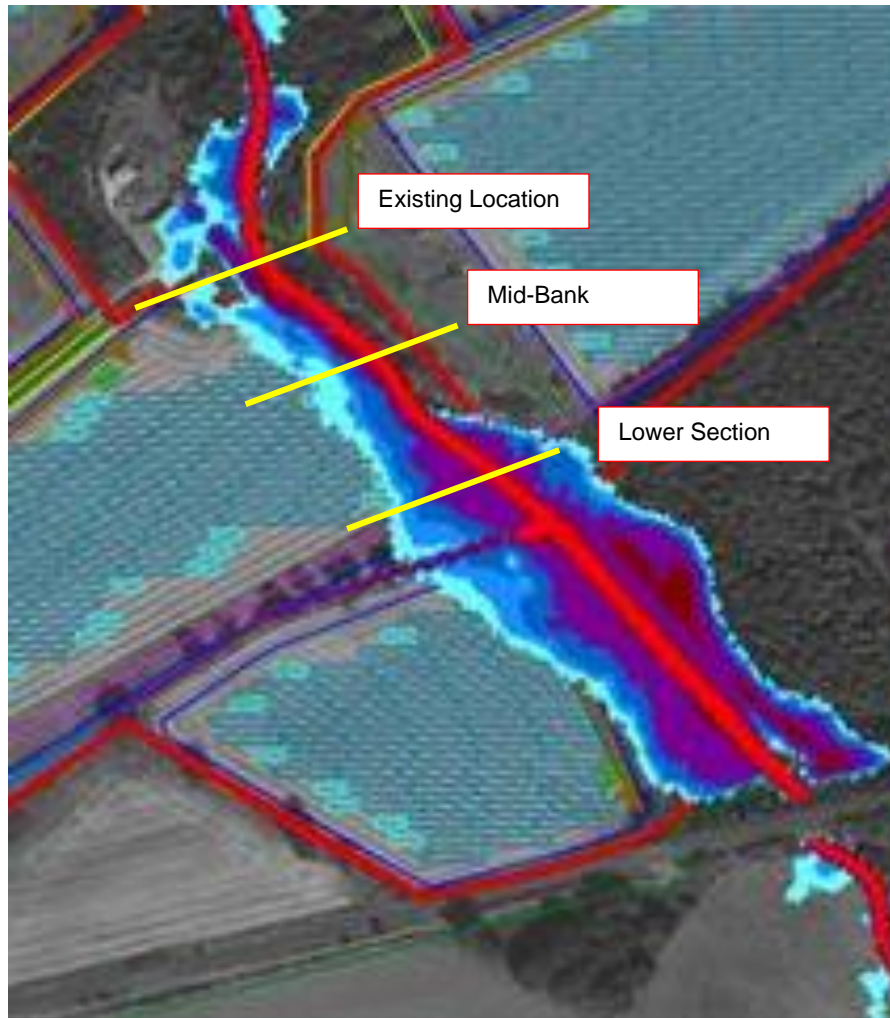
Figure 1 - Abstract from Flood Risk Assessment

4.2.1 SLR have undertaken Flood Risk Assessment and Drainage Impact Assessment¹ for the area. This suggests substantial flooding in the area in the event of a 1:200yr + 39% climate change flood event. This would include flooding of the western access route, with the bridge deck being overtopped (See Figure 1 below). It is unlikely that the existing bridge would survive this scenario.

- 4.4.2 Following a review of the Flood Risk Assessment and Drainage Impact Assessment² SLR considered three locations downstream of the existing bridge location for the revised structure, these are shown in Figure 1, and identified as Existing Location, Mid-Bank and Lower Section.

- 4.4.3 The benefit of this site is that the existing site access track is already routed to this location. However, the existing location appears to have a wider extent of deeper flooding for the 200-year storm, likely due to the flat area upstream and the adjacent mill lade. As such the new structure would likely need to be installed higher and have a longer span than the existing structure and the access tracks would have to be raised above the proposed flood limits to ensure use in high flood events.

- 4.4.4 Immediately to the south of the existing bridge, the flooding extent map shows a slight constriction of the limits of the flooding, this may provide an opportune location for the new structure as it will limit the length of structure required. However, as can be seen in Figure 1, the flooding does infringe on the limits of the solar layouts and the road design may require some slight movement of the panels to accommodate. There would be additional earthworks on either side of the bridge to allow the existing access track to reach this location and form abutments.

- 4.4.5 Downstream, the high bank on the east side continues for around 130m, where it then drops off for 50m before entering a wooded section ultimately before leaving the site. This lower section may offer a far easier construction for a temporary or permanent replacement bridge. The downstream location is considered unsuitable due to the significant extent of flooding in that area. Constructing a bridge at this point would require a substantially larger structure to span the wider flood extents.
